## Biomonitoring of Betwa River of M.P.

**Objective:** This project is aimed to assess the water quality of entire stretch of river Betwa in Madhya Pradesh by Biological Water Quality Criteria [BWQC] which used for evaluating water quality based on identification of macro invertebrate families.

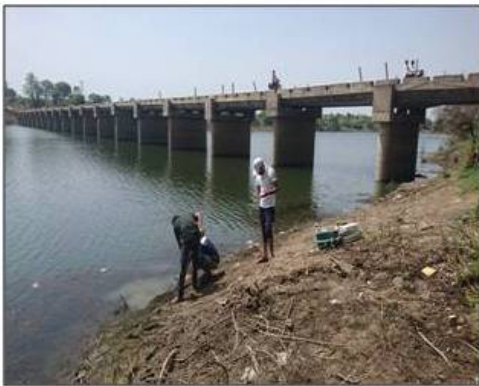
Picture: River Betwa, near Road Bridge, Ganj Basoda

8.	Near road bridge, Ganj Basoda	C	B	B	B	Due to Anthropogenic activities (cattle wadding)
9.	Near road bridge, Kurwai	C	B	C	B	Due to anthropogenic activities, vehicle washing

8.	Near road bridge, Ganj Basoda	B	C	C	*	Due to Anthropogenic activities (cattle wadding) * monitoring Scheduled
9.	Near road bridge, Kurwai	B	B	C	*	Due to anthropogenic activities, vehicle washing * monitoring Scheduled

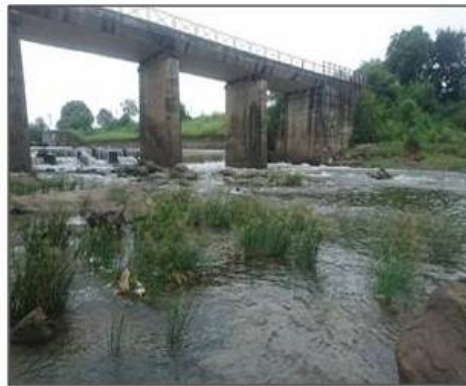
Picture: River Betwa, near road bridge, Bhojpur

4.	Near road bridge, Bhojpur	C	B	B	B	Human influences (Religious activities)
5.	Near Road Bridge Pagneshwar, Raisen	C	C	B	*	Due to Idol immersion water quality degrade. * sampling not done due to drought

4.	Near Road Bridge, Bhojpur	B	C	B	C	Human influences (Religious activities)
5.	Near road bridge Pagneshwar, Raisen	B	C	B	B	Due to Idol immersion water quality degrade.

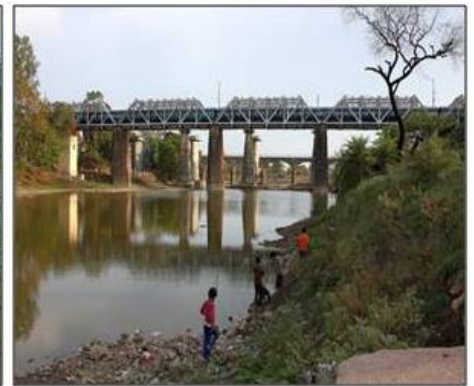
Picture: River Betwa, near railway road bridge, Vidisha

6.	Near railway road bridge, Vidisha	C	C	C	C	Due to Idol immersion water quality degrade
7.	Near intake point, Vidisha	C	B	B	C	Due to Anthropogenic activities (cattle wadding)

6.	Near railway road bridge, Vidisha	B	C	C	B	Due to Idol immersion water quality degrade
7.	Near intake point, Vidisha	C	C	C	B	Due to Anthropogenic activities (cattle wadding)

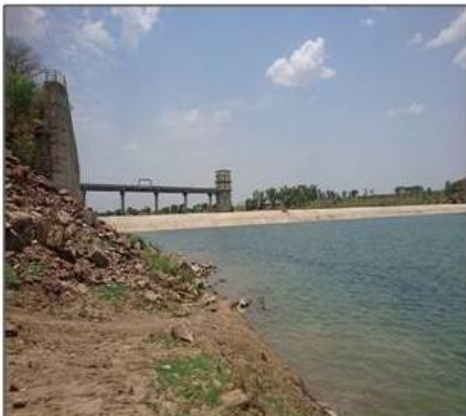
Picture: River Betwa, near Bina Refinery (Mahoota)

10.	Near Bina Refinery(Mahoota), Bina	B	B	B	B	Stop Dam constructed by BORL, Agriculture activities
11.	Near road bridge, Orchha	B	B	C	C	Due to Idol immersion water quality degrade

10.	Near Bina refinery(Mahoota),	B	B	B	*	Stop Dam constructed by BORL,

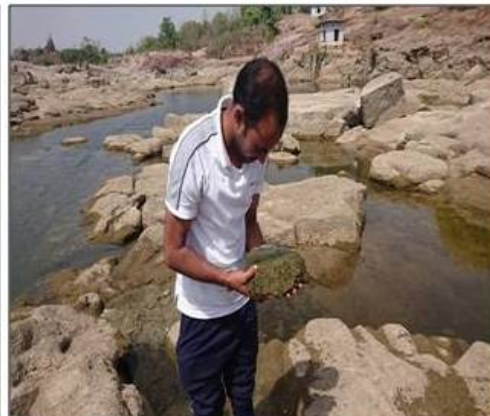
Picture: River Betwa, near Behind Bundelkhand Resort, Orchha

12.	Behind Bundelkhand Resort, Orchha	B	B	C	B	Human influences (Religious activities)
